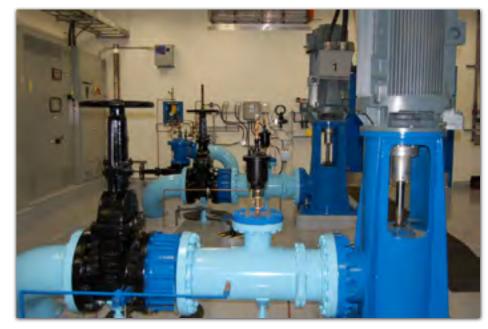
Figure 5 - Zone 1 Pumping Station at Canoe Beach

down through all the zones, with the exception of Zone 5. The pump stations house a combined total of 15 pumps with a service life of approximately 40 to 50 years for each pump.

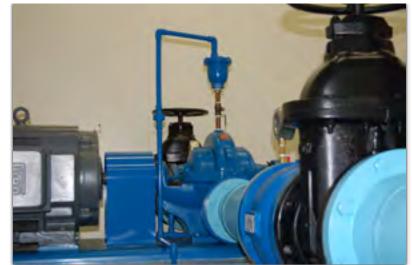
• Figure 6 – Zone 4 Pump/Pressure Reducing Station on 30th Street NE

The maximum design water pressure for piping within the municipal water system is 1034 kPa (150 psi). We have five pressure reducing valve stations containing one Pressure-reducing valve (PRV) each. Pressure reducing valves are used to control the pressure in the water system by creating head losses that prevent pressures from exceeding the design maximum. The failure of a PRV could disrupt flows and mainline pressures to a large area of the community.

The Utilities Department currently overhauls the PRV stations every year in an effort to extend their service life. Most individual premises also have secondary PRV's as fluctuating pressures can place excessive stress on internal plumbing systems and fixtures.

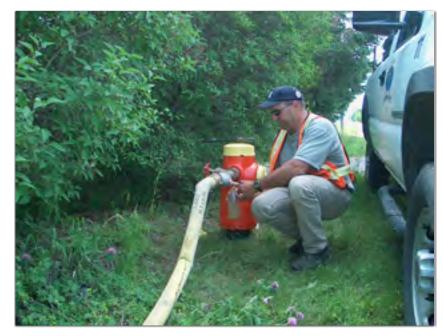
Figure 8 – Utilities Department operator flushing watermain as part of regular maintenance

As water travels from the watersheds, it collects organic particles and transports them to the water system. As these particles travel to areas of the water system with lower flow velocities they settle out. Accumulated debris and stagnant water inhibit flow through mains, cause dirty water and potentially create a favourable environment for bacterial growth. In response to these concerns, the Utilities Department initiated a watermain flushing program for identified problem areas. Each main is flushed annually during daytime hours. When flushing, a hydrant is opened and the water stream is used to expel the contents of the main. There are approximately 17 locations throughout the municipality referred to as "high maintenance areas" where water demand is low or where watermains terminate in a dead

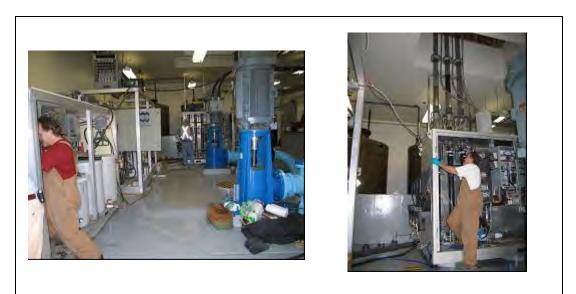
Figure A.1 Pilot-Scale Equipment at the Canoe Beach Pump Station

Terasen Water was retained to install and commission all pilot-scale equipment. The equipment was located at the Canoe Beach Zone 1 Pump Station. Figure A.1 shows photos of the pilotscale testing location.

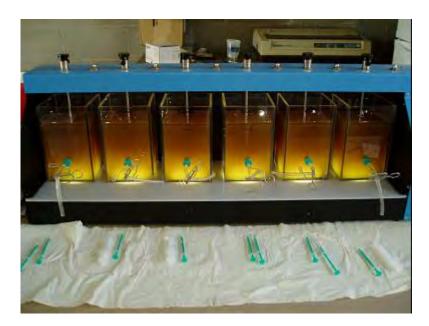
Figure A.9 – Backwash water samples at the start of the settleability tests.

Table A.13 shows the results obtained for the test number 3 (see **Table A.8**). Backwash water was allowed to settle with and without coagulant and coagulant aid addition. A dose of 25 mg/L of alum and 1.5 mg/L of Isofloc 222 were added to backwash water and compared to the sample without chemical addition. For each scenario, two samples were collected; the first in the beginning of the backwash cycle, and the second corresponding to a composite of samples collected throughout the backwash cycle. The first set of samples corresponded to the worst-case scenario, while the second intended to more accurately portray the effluent generated throughout the backwashing process.

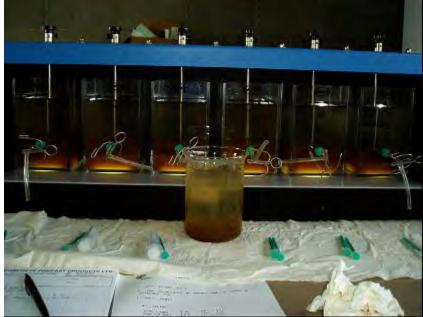
Figure A.10 – Backwash water samples after 15 minutes of settling time (From the left; PACI 10, 25 and 40 mg/L, and 0, 25 and 40 mg/L of alum). Control test (with no chemical addition) was performed in the beaker shown.

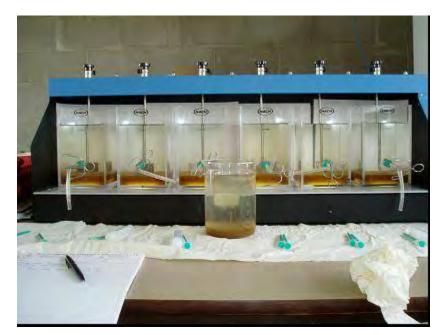
Figure A.11– Backwash water samples after 25 minutes of settling time (From the left; PACI 10, 25 and 40 mg/L, and 0, 25 and 40 mg/L of alum). Control test (with no chemical addition) was performed in the beaker shown.
