The Insurance Corporation of British Columbia (ICBC) and the City, with the consultation with BC Ministry of Transportation and Infrastructures (MOTI), have retained ISL Engineering and Land Services to perform a safety and operations corridor study for the TCH between Shuswap Street and 6 Street, as shown in **Figure ES.1**.

In 2009, a *Town Centre Transportation Plan* was undertaken for the City of Salmon Arm (the City). From the results of the Transportation Plan, improvement strategies for various timeframes were recommended: Immediate & On-going, Short Term (< 5 years), Medium Term (5-10 Years), and Long Term (10-20 years). A collision analysis was also performed at five intersections along the Trans-Canada Highway (TCH) to assess the existing safety level in the corridor using BC Ministry of Transportation and Infrastructures (MOTI) Collision Information System database. It was expected that some recommended improvement measures may impact the future traffic operations and safety conditions along the TCH Corridor; therefore, the Insurance Corporation of British Columbia (ICBC) and the City have retained ISL Engineering and Land Services to perform a safety and operations cor

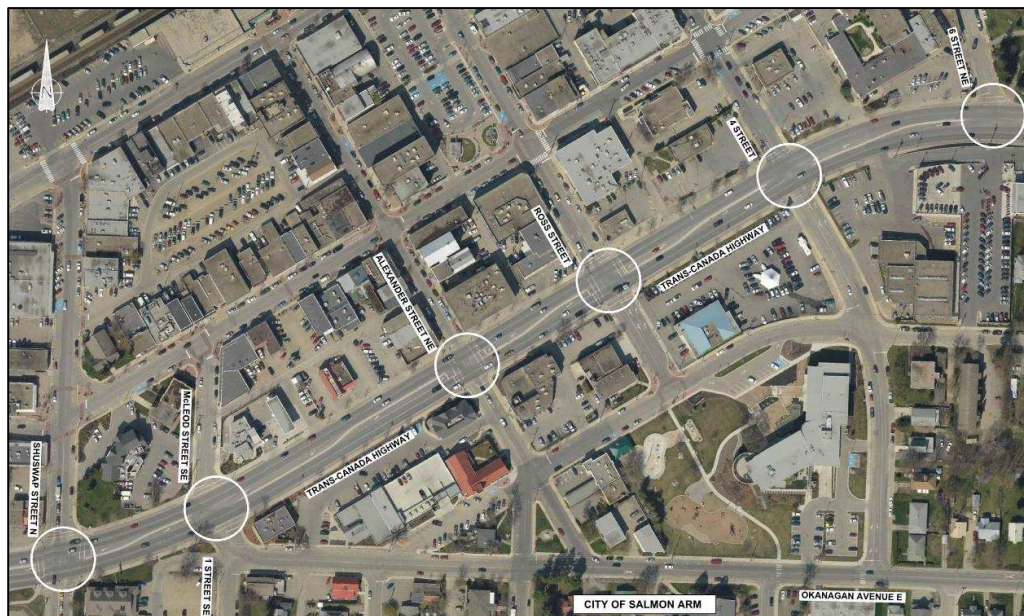
**Figure 1.1: TCH Study Corridor**

In addition to a corridor-wide safety review, the following six intersections were identified to have traffic operations and safety reviews would be conducted, as shown in **Figure 1.1**:

- TCH at Shuswap Street (signalized)
- TCH at McLeod Street (stop-controlled on side streets)
- TCH at Alexander Street (signalized)
- TCH at Ross Street (signalized)
- TCH at 4 Street NE (stop-controlled on side streets)
- TCH at 6 Street NE (stop-controlled on side street)

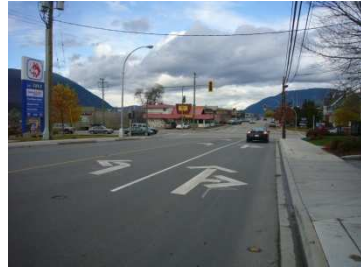
Left-turn lanes are always provided on TCH approaches but designated left-turn phases are not provided at signalized intersections, with the exception of the eastbound and

westbound left-turn movements at Shuswap Street. In general, a shared left-turn/through lane and a designated right-turn lane are provided at signalized intersection side streets; however, it was also noted that a designated left-turn lane and shared through/right-turn lane on side streets was recently painted at the Shuswap Street intersection. A one-way northbound lane is located on the north leg at the Alexander Street intersection.

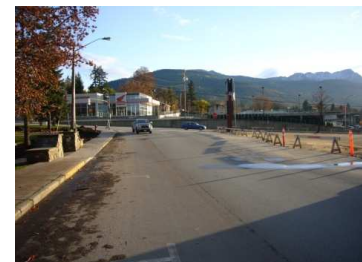
Sidewalks are provided along both sides of the TCH, generally directly adjacent to the roadway without grassed boulevards, although utility strips are provided along some sections of the highway. Side streets also generally have sidewalks on both sides; with the exception of 6 Street which has parallel park trails on the east side. The west side of 6 Street was being worked on by construction crews during the site visit; however, it is understood that the sidewalk will not be constructed on the west side of 6 Street as part of the building/parking lot improvements.

Marked crosswalks are located on all of the legs of the signalized intersections of the TCH with Shuswap Street, Alexander Street, and Ross Street. Push buttons with activated audible signals with “walk” and “don’t walk” indicators are also provided. Marked crosswalks are also provided to cross the side streets along the TCH at the stop-controlled intersections of McLeod Street, 4 Street, and 6 Street.

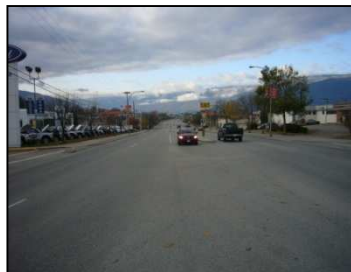
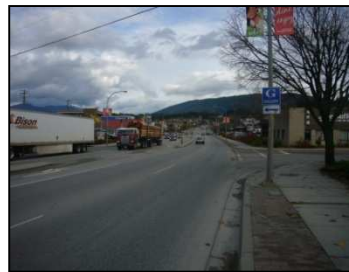
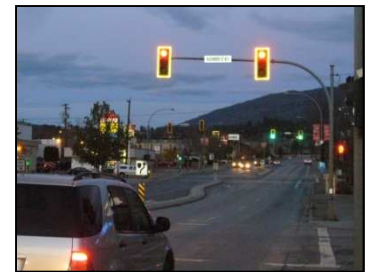
- Transit stop and bus services were not found on the study corridor.
- Adjacent to the corridor are properties with commercial uses including retail and restaurants. Many of these properties had driveways to the TCH.

- Sun glare affects visibility of the primary signal heads along the TCH due to the orientation of the road, while there are few large and tall buildings or other obstacles to block the sun while it rises and sets.

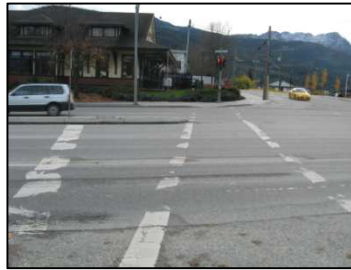
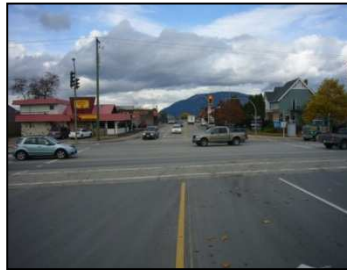
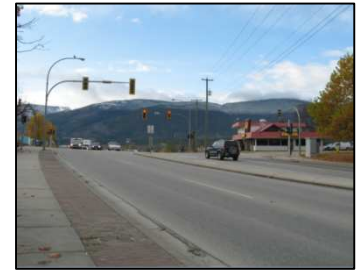
### 3.2 Shuswap Street at TCH

- The intersection is located on the top of a crest curve, with the combination with horizontal alignment, limiting view of the oncoming direction for approaching drivers, in particular westbound left-turn traffic.
- In some areas the asphalt appeared to be in poor condition and pavement markings were faded.
- North-south left-turn lanes are misaligned due to the recent re-painting of pavement markings.
- Northbound lane has recently been painted.
- Heavy oil tankers turning into and out of the south leg for accessing the gas station.

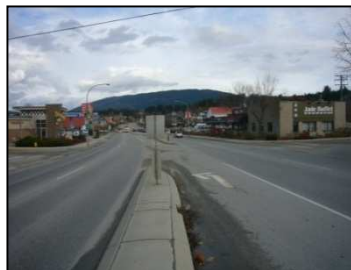
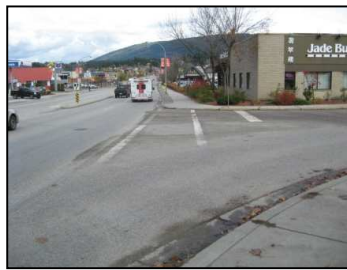
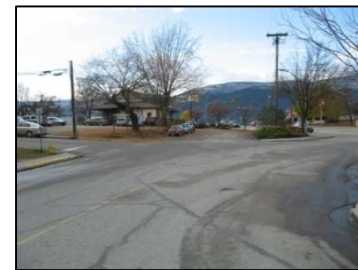
### 3.3 McLeod Street at TCH

- Traffic volume of turning vehicles was low at the intersection.
- Approximately 15 metres south of the intersection there is a 4-legged intersection of 1 Street SE with Okanagan Avenue E and an alley.
- Northbound and southbound drivers have poor visibility due to intersection skew.
- Short eastbound left-turn lane length due to the close proximity of the Shuswap Street intersection.
- Northbound and southbound approaches are wide and right-turn drivers' visibility could be blocked by left-turn vehicles.
- Faded pavement markings across the McLeod Street approaches.

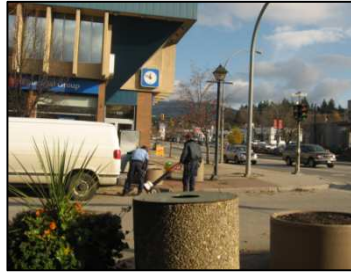
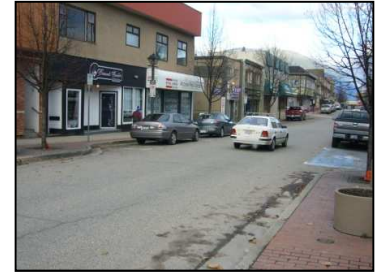
### 3.4 Alexander Street at TCH

- Alexander Street north leg is northbound one-way only with on-street parking on both sides.
- Vehicles were observed unloading on Alexander Street just north of the TCH, in a no-stopping zone.
- A relatively high number of pedestrians were observed crossing the TCH at this location compared to the other study intersections.
- Accesses to shopping malls just south of intersection.

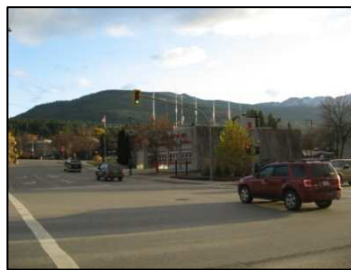
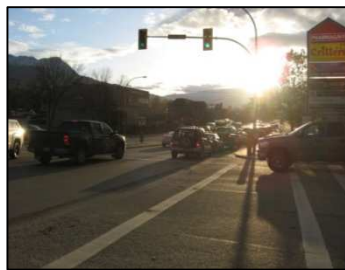
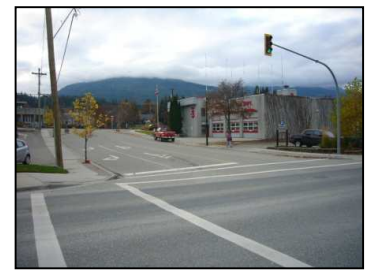
### 3.5 Ross Street at TCH

- A fire hall is located on Ross Street, just south of the intersection. Emergency vehicles use the intersection at Ross Street to access the TCH and their destinations.
- It was observed that eastbound vehicles would speed up after passing through Alexander Street, on the Ross Street approach, possibly in anticipation of the uphill grade ahead.
- A relatively high number of pedestrians, including secondary school students, were observed crossing the TCH Highway at this location compared to the other study intersections.
- During the peak periods, there would be queuing at this intersection including on westbound TCH.
- The northbound (shared left / through) lane may become queued when the westbound TCH is backed up and northbound traffic is unable to turn left.

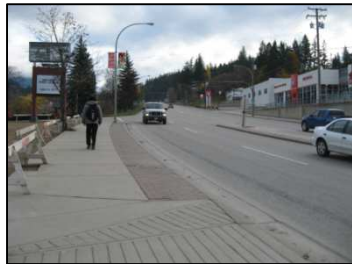
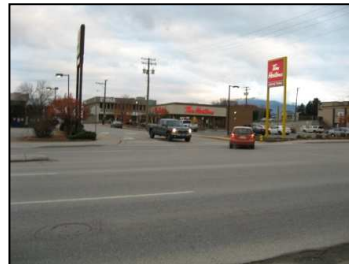
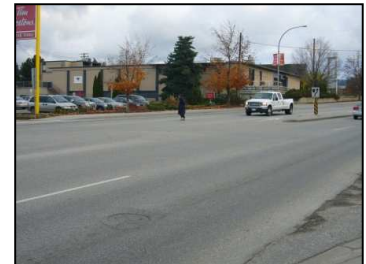
### 3.6 4 Street at TCH

- Relatively high turning volumes were observed travelling to/from the coffee shop (Tim Hortons) and convenience store (7-11) located on the north-east corner compared to the other stop-controlled study intersection.
- Pedestrians were observed crossing the TCH at 4 Street to access the coffee shop.
- The primary coffee shop access is located on 4 Street, approximately 10 metres north of the intersection.
- Relatively high vehicle speeds were observed in the westbound direction.
- The car dealership access is very close to the intersection on the south leg.

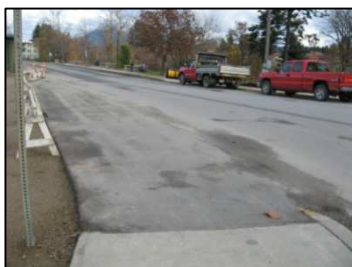
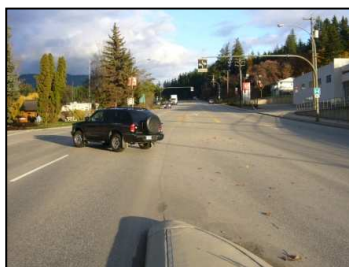
### 3.7 6 Street at TCH

- Poor street lighting was observed along 6 Street southbound during the night site visit.
- The road was partially under construction during the site visit; however, it appeared that the sidewalk adjacent to the southbound approach ended abruptly with asphalt. It was unclear what the purpose of this area was.
- A car dealership access is located access from 6 Street and offset east by approximately 60 metres. The use of the 2-way left-turn lane by traffic from both accesses for turning left to/from the highway may result in conflicts.
- Relatively high pedestrian volumes crossing 6 Street are expected to be high during the weekends and summer due to the proximity of the McGuire Lake Park.

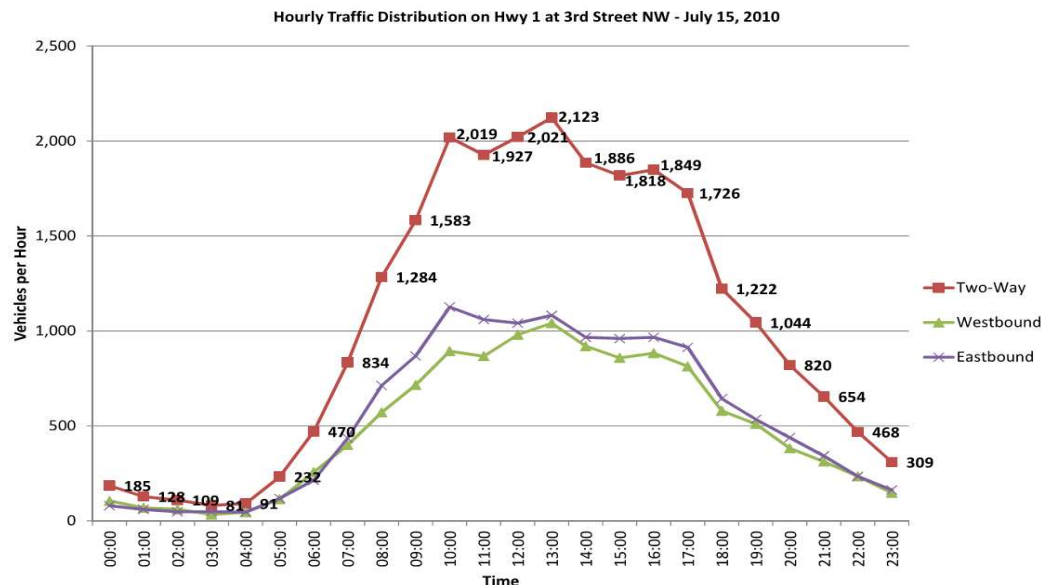
**Figure 4.1: Hourly TCH Traffic Volumes Distribution**

- Morning (AM): 0730 to 0930 hours;
- Midday (MD): 1200 to 1400 hours; and
- Afternoon (PM): 1500 to 1700 hours.

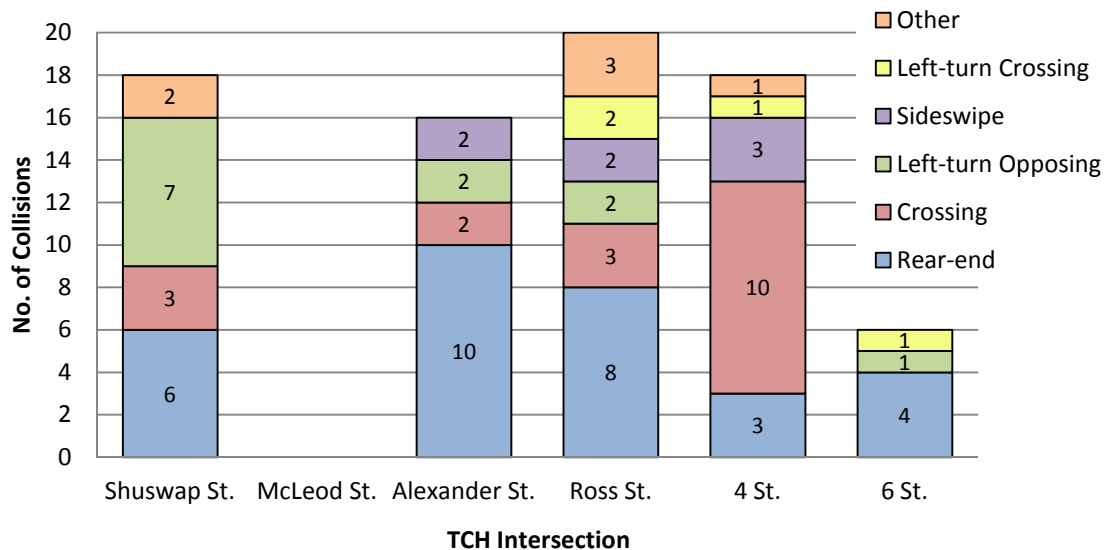
**Figure 5.6: Collision Type Distribution**

The collision type distribution for each intersection was also determined and summarized in **Figure 5.6** (bar graph) and **Figure A.5** in **Appendix A** (individual pie charts).

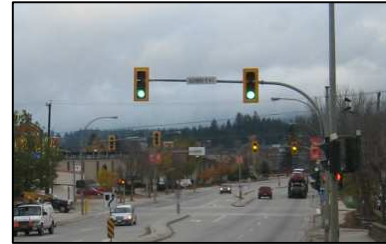
The TCH is a major goods movement route through British Columbia. During the daytime peak and off-peak hour traffic, the highway traffic through the study corridor was generally made up of approximately 10% heavy vehicles and long trucks. These vehicles may cause safety issues as they usually require more time to decelerate when approaching the red signal light. It also takes additional time for heavy trucks to pick up to posted or operating speed when the signal lenses change to green light. As well, passenger car drivers travelling behind these heavy vehicles may have limited visibility of signal heads at the intersection approach and do not stop in time for unexpected red signal light. Some aggressive drivers may be frustrated and try to overtake heavy vehicles close to intersection approaches, causing sideswipe and rear-end collisions and conflicts.

Based on information provided by MOTI, the signalized intersection of Shuswap Street, Alexander Street, and Ross Street are currently coordinated. According to the site observations in November 2012, many vehicles are required to stop at either the Alexander Street or Ross Street intersections. This may be due to heavy vehicles accelerating slowly between the intersections, causing following vehicles to miss the green phase at the downstream signals. It is recommended that offset times of these intersections be reviewed and compared to corridor observations, such as revising the operating speed used in the model. If the TCH signal is relocated from Ross Street to 4 Street (Traffic Control Scenario 3-5), the signal timing plan will be revised as well as the off-set times.

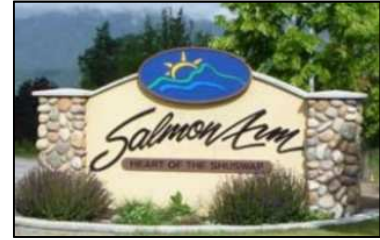
To enhance the expectation of crossing pedestrians and stopping vehicles (at signals) along the corridor, it is important that drivers become aware when they are transitioning from a rural/suburban area and highway section to an urban centre area and roadway corridor. A clear “Town Centre Gateway” notification should be created at each end of the study corridor with the use of road signs and artwork to welcome drivers to the Salmon Arm Town Centre. This could be in the form of large road signs similar in style to those seen when entering the City. It could also be flags hung off luminaire poles similar to those already on the corridor, or banners over the roadway.

To reduce travelling from a high vehicle speed from the rural section to a 50-km/h speed zone Town Centre section, installation of speed reader boards (as shown in the photo downloaded from the website) on the both end of the Town Centre can be considered. In addition, the City of Salmon Arm Speed Watch Program could concentrate on the study corridor. The program is conducted in partnership with the local police, community volunteers and ICBC. It is an education program aimed at reducing incidents of speeding with raising the driver’s awareness of travelling in high vehicle speed, particularly entering the town centre.
